Control Surfaces - Elevator Hinge Bracket - Sta. 7 - Static Test - Date of  
Test 16 and 28 July 1945 - Model XB-36

MODEL XB-36

CONTROL SURFACES - ELEVATOR HINGE BRACKET -

### STA. 7 - STATIC TEST

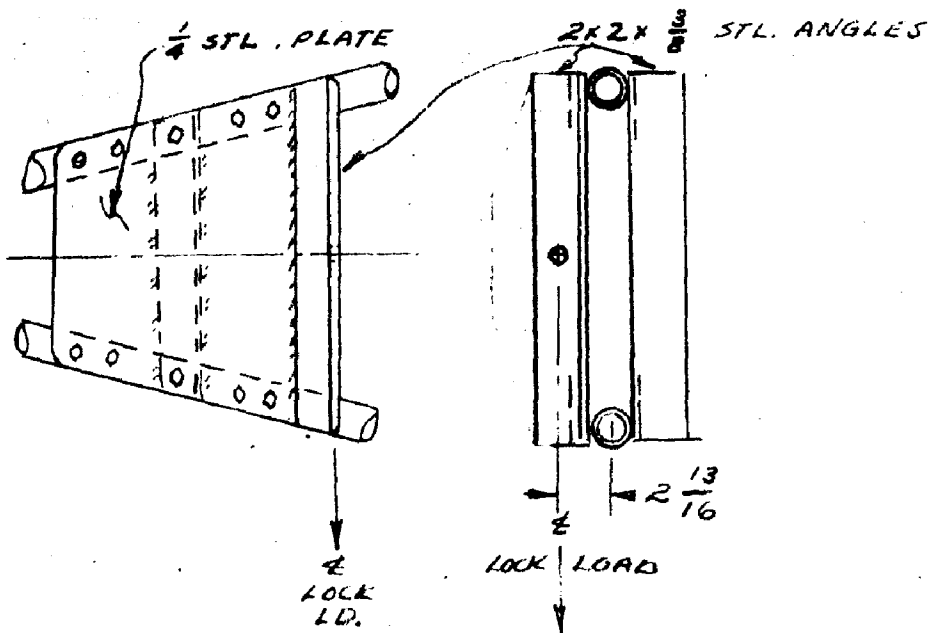
The lock mechanism was not available but was simulated by a steel bracket as shown below:

Specimen 36T669-0 consisted of two .083 gage 3" X4130 steel tubes, two 36T671-6 magnesium fork end fittings, one 36T670 adjustable elevator hinge fitting, also made of magnesium, and a dummy steel lock bracket. The bracket was assembled with the hinge line at 28.5 % of the elevator chord.

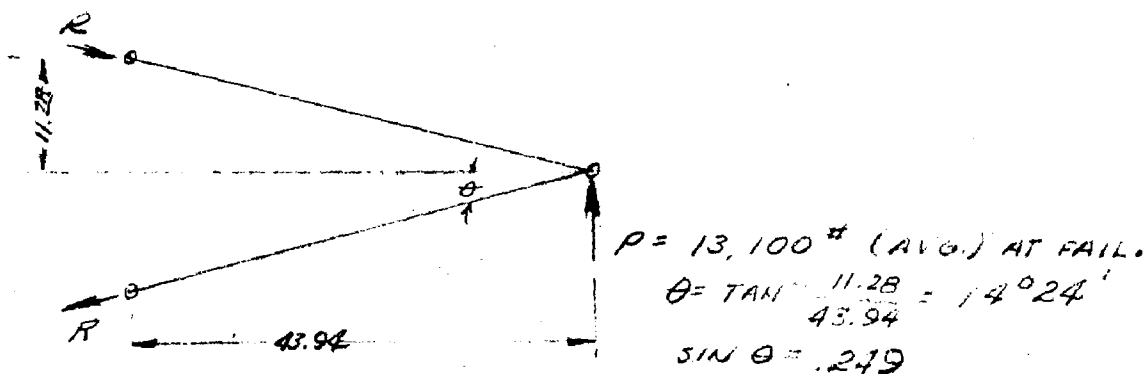
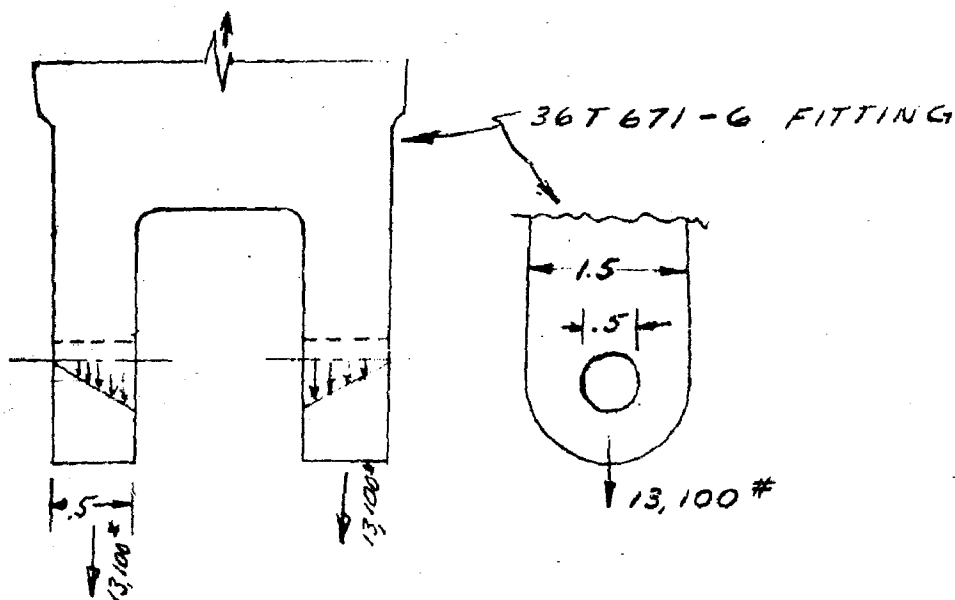
$R = \text{MEMBER LOAD} = \text{TENSION ON FITTING}$   
 $= \frac{13,100}{2 \times .249} = 26,200 \text{ # AT FAILURE}$

ASSUMING TRIANGULAR DISTRIBUTION OF 13,100 # LUG LOAD

$$\text{MAX. } f_c = \frac{P}{A} + \frac{My}{I} = \frac{13,100}{.5 \times 1} + \frac{13,100 \times .083}{\left(\frac{1 \times .5^3}{6}\right)}$$

$$= 26,200 + 26,000 = 52,200 \text{ P.S.I. AT FAILURE}$$

The above differences in stress indicated a discrepancy in the basic assumption that the forks were axially loaded. An analysis based on a triangular distribution is shown on the succeeding page; the calculated maximum stress is 52,200 psi.

A comparison of this 52,200 psi stress with the material value of 51,000 psi obtained from test coupons of the actual fittings indicates that the assumption of triangular pressure distribution is conservative by approximately

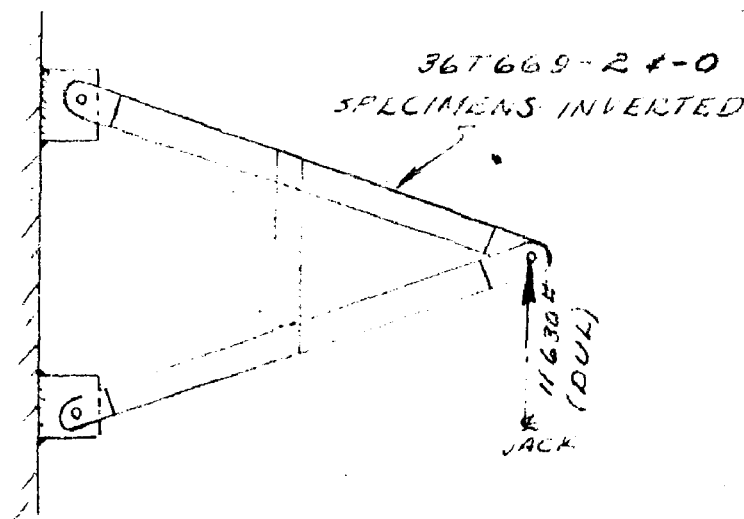
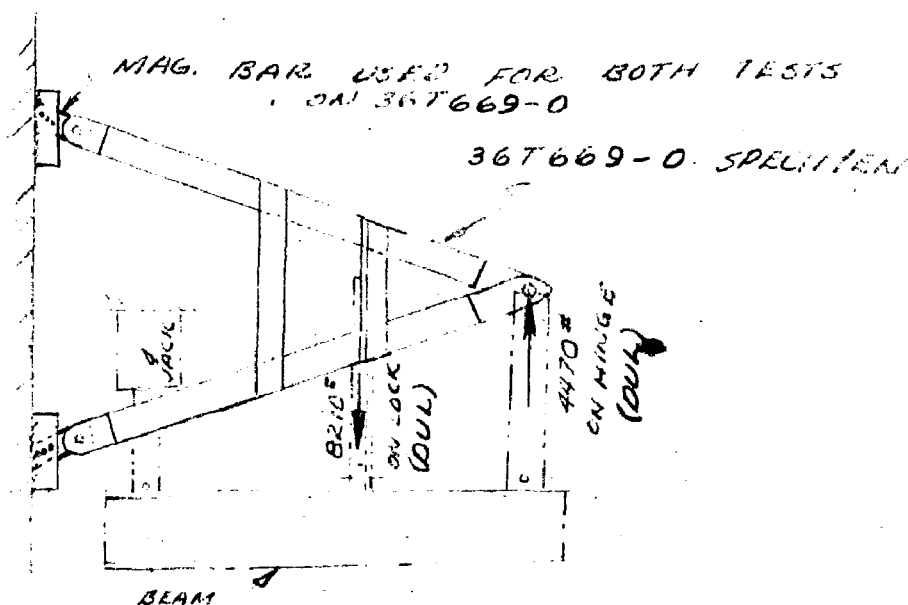
FIG. 2

SET UP FOR L.A.H. COND.

SET UP FOR LOCKED COND.

FIGURE 2 - DIAGRAMS OF TEST SET UPS

**TEST SET-UP AND PROCEDURE:** Specimen 36T669-2 was tested for the down load condition as shown in Figures 2 and 3. The lateral support offered by the elevator and stabilizer was simulated by restraining the side movement of the load column which received the thrust of a 12 ton calibrated hydraulic jack. A dial gage was set up to check the lateral movement of the column, if any.

Specimen 36T669-0 was tested for the combined hinge and lock load condition as shown in Figures 2, 6 & 7. By means of a loading beam the thrust of the 12 ton calibrated hydraulic jack supplied a down load at the lock bracket and an up load at the hinge point. Lateral support at the hinge point was provided in the same manner in testing this specimen as for specimen 36T669-2. Since this specimen withstood 212 % of the design ultimate load without failure it was also tested for the hinge load condition.

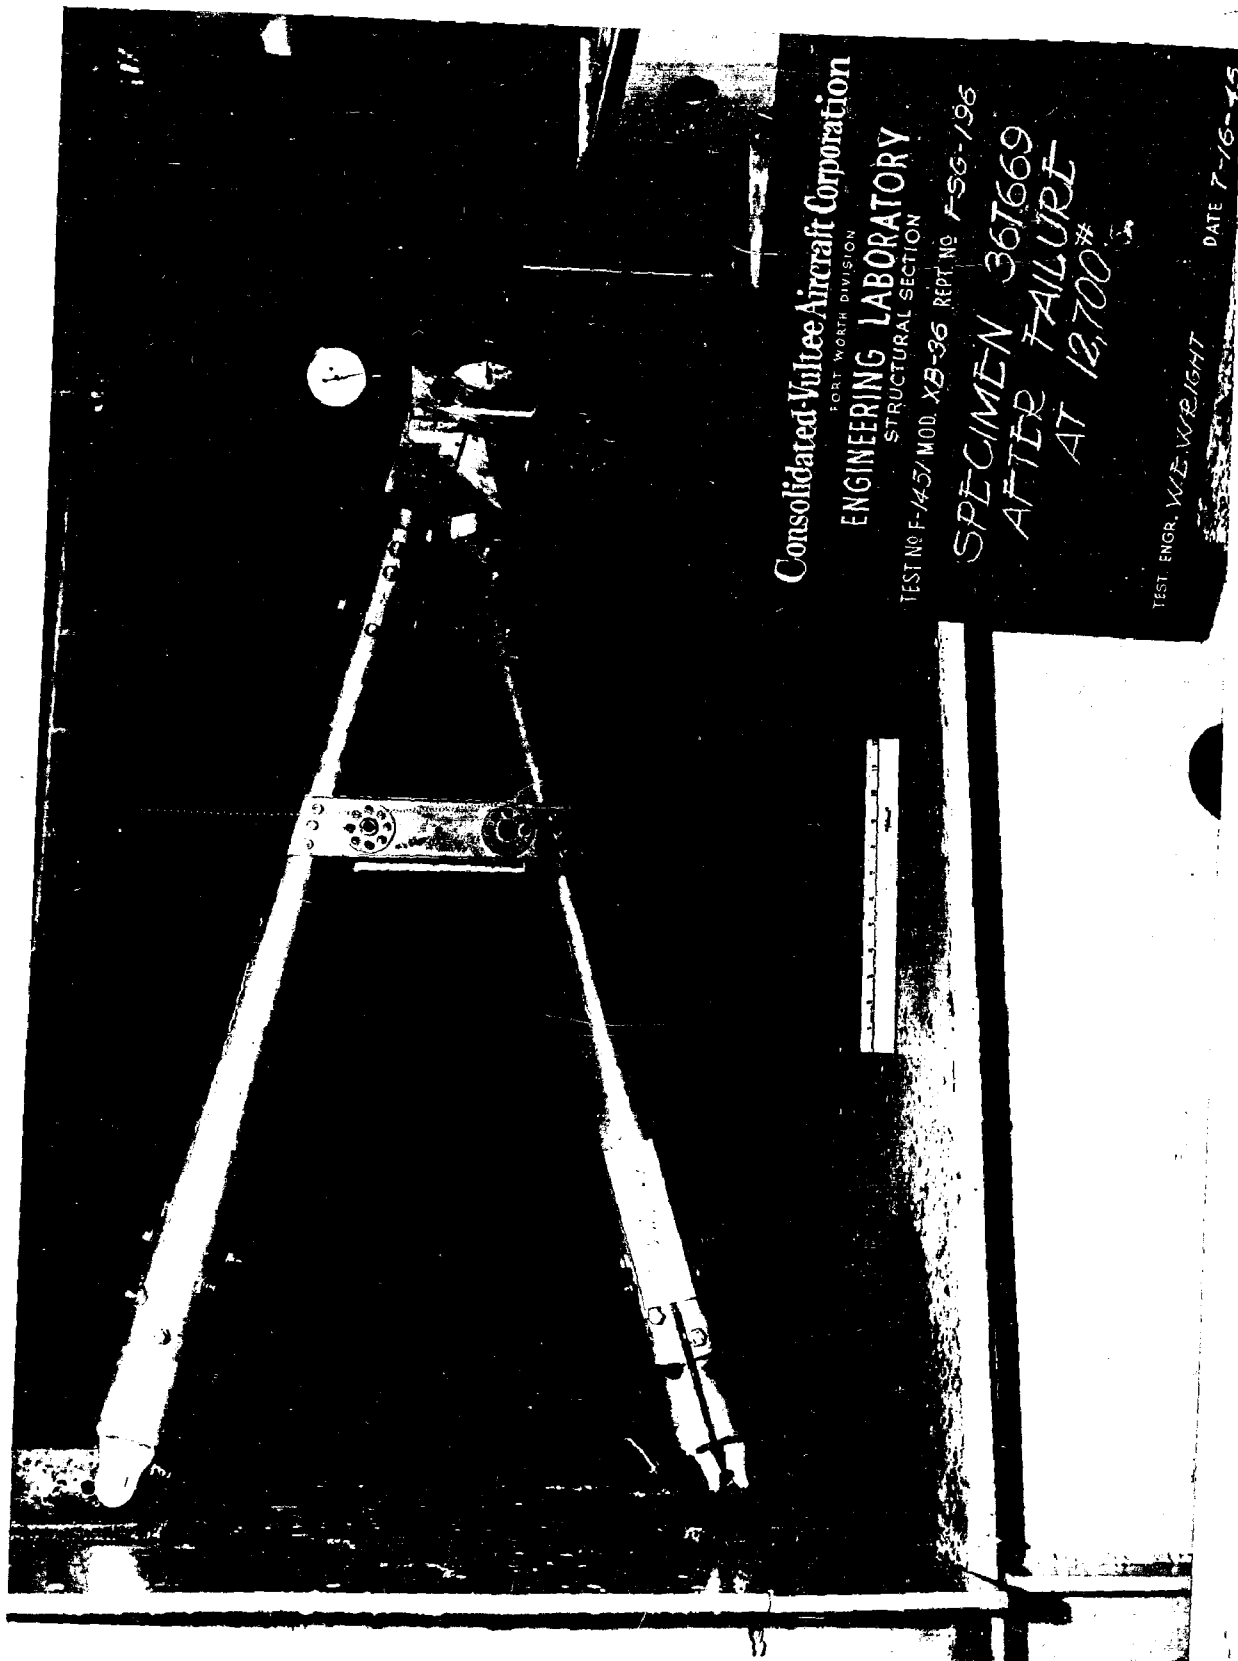
FIG. 3

SPECIMEN 367669  
AFTER FAILURE  
AT 12,700#

**RESULTS:** Specimen 36T669-2 supported the design yield load of 7,650 # and withstood the design ultimate load; end fitting 36T671 failed in tension at the net section under a load of 12,700 #, 110 % of the design ultimate load of 11,500 #. See Figures 3, 4, and 5 for details of failure. No permanent set after the design yield load was noted.

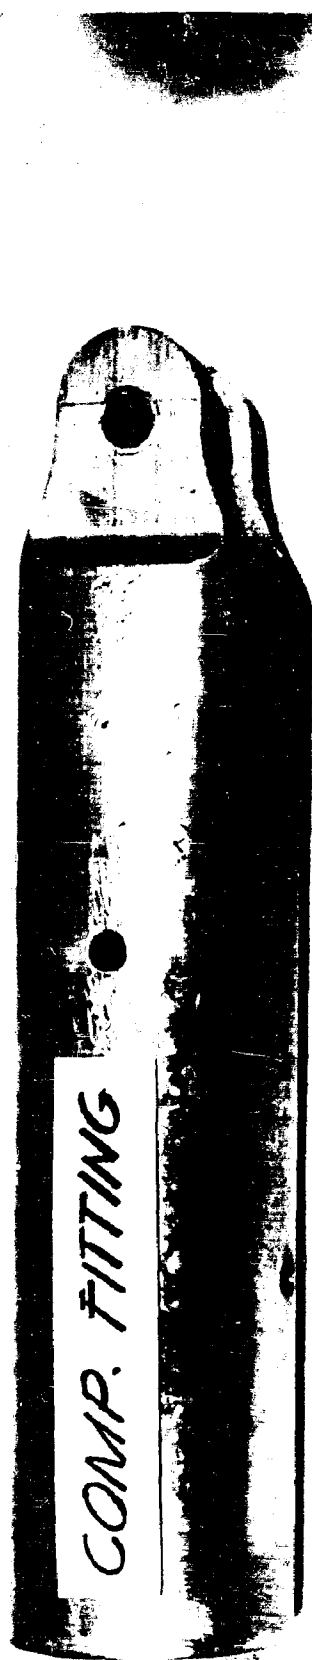
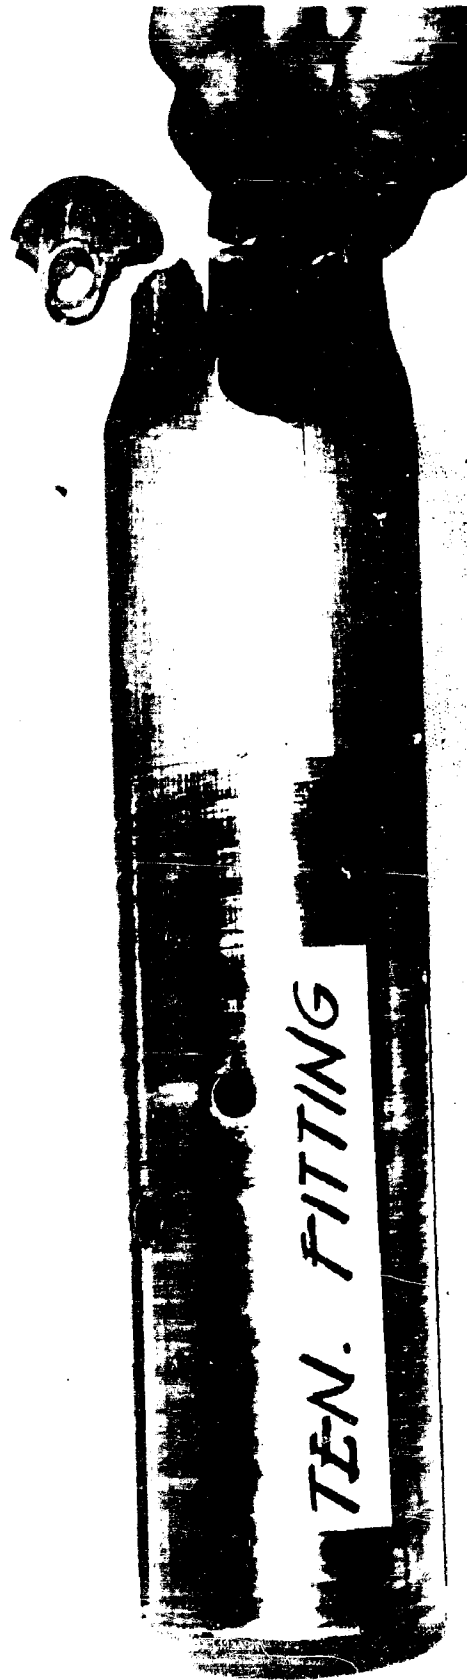
FIG. 4

2-5089 7-17-45  
DETAIL-TENSION FAILURE  
END FITTING 36T671-6-  
MODEL XB-36-REPT. FSG-196.  
CVAC. FT. WORTH TEX.

**DISCUSSION:** In view of the fact the  $\frac{1}{2}$ " hinge attachment bolts showed considerable bending it became apparent that failure was influenced by this condition. The fork fitting which failed in tension was designed on the assumption that the  $\frac{1}{2}$ " bolt loaded each prong of the fitting axially giving a stress at failure,  $P/A = 25,700$  psi. Material coupons from this fitting, however, indicated an allowable ultimate tensile stress of 51,000 psi.

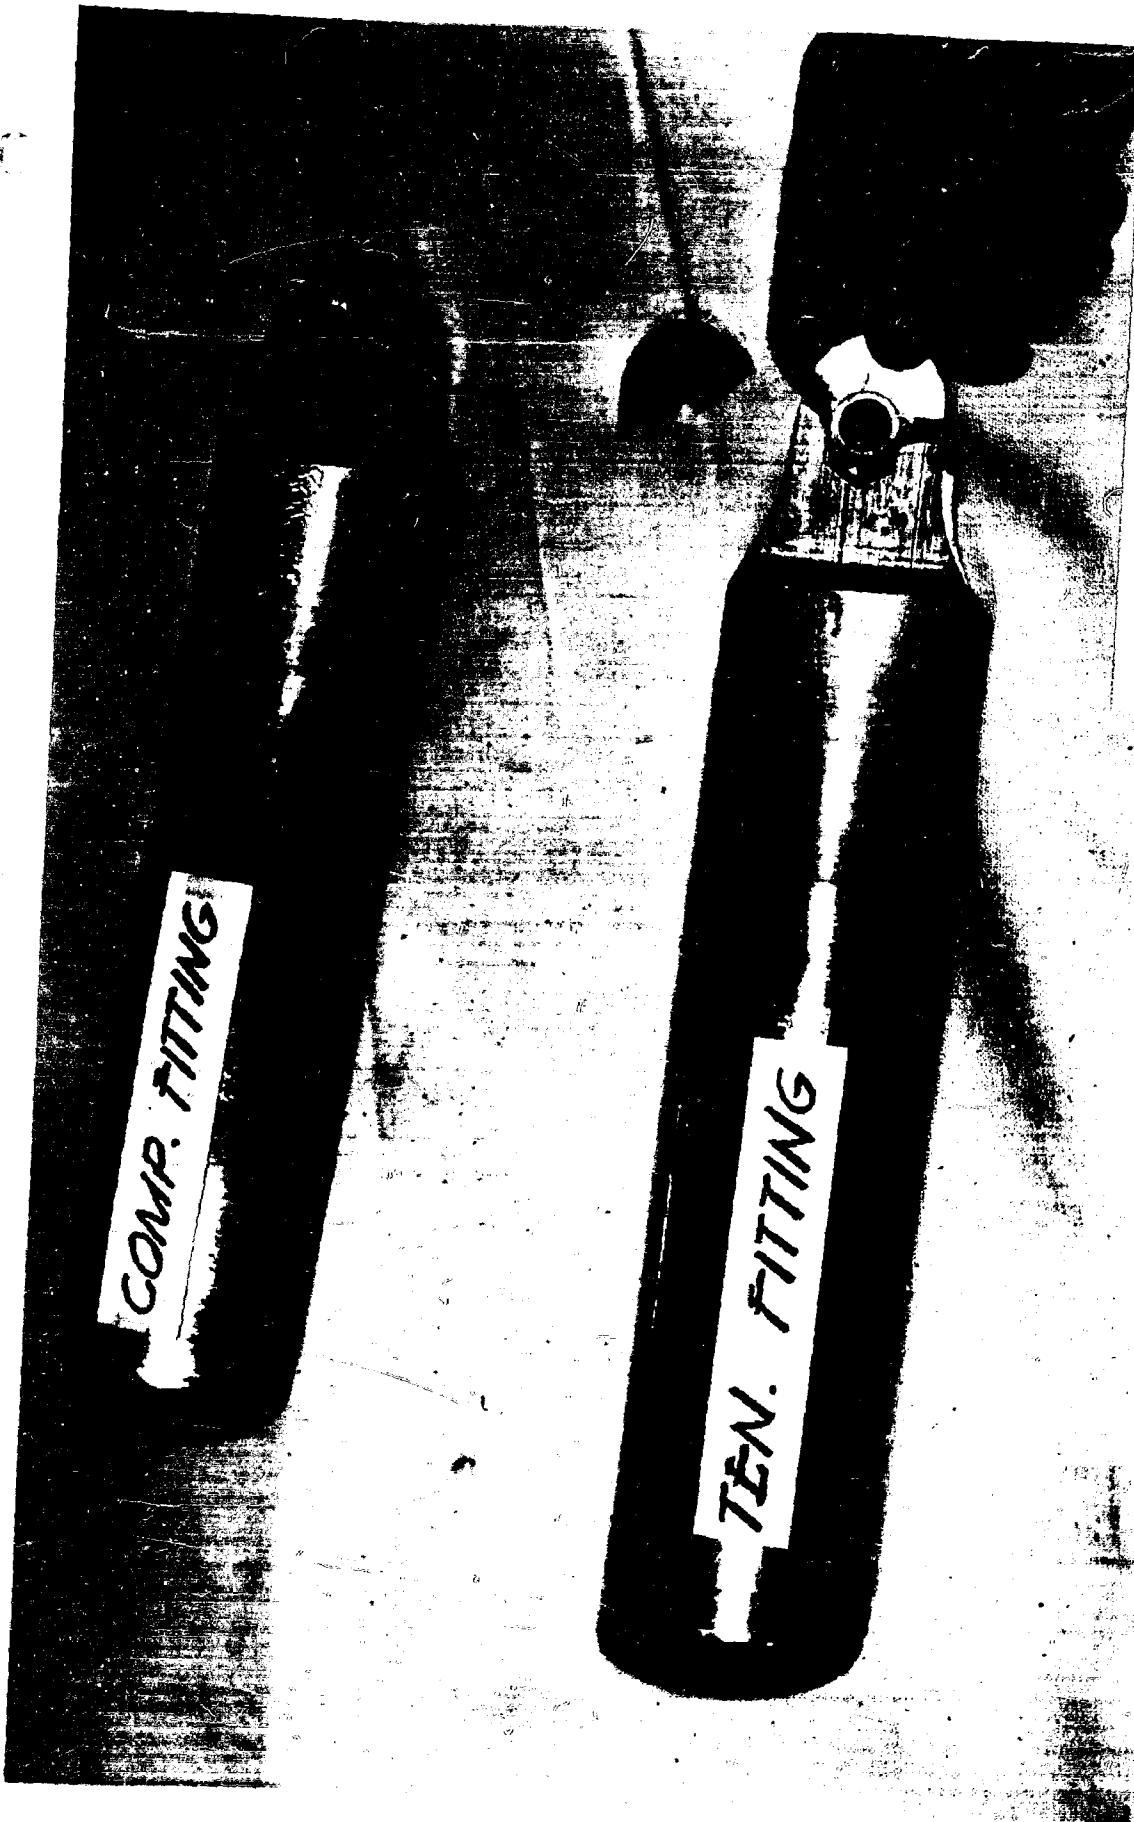
FIG. 5

2-5088  
7-17-45  
DETAIL-TENSION FAILURE  
END FITTING 36T671-6-  
MODEL XB-36-REPT. FSG-196.  
CVAC. FT. WORTH TEX.

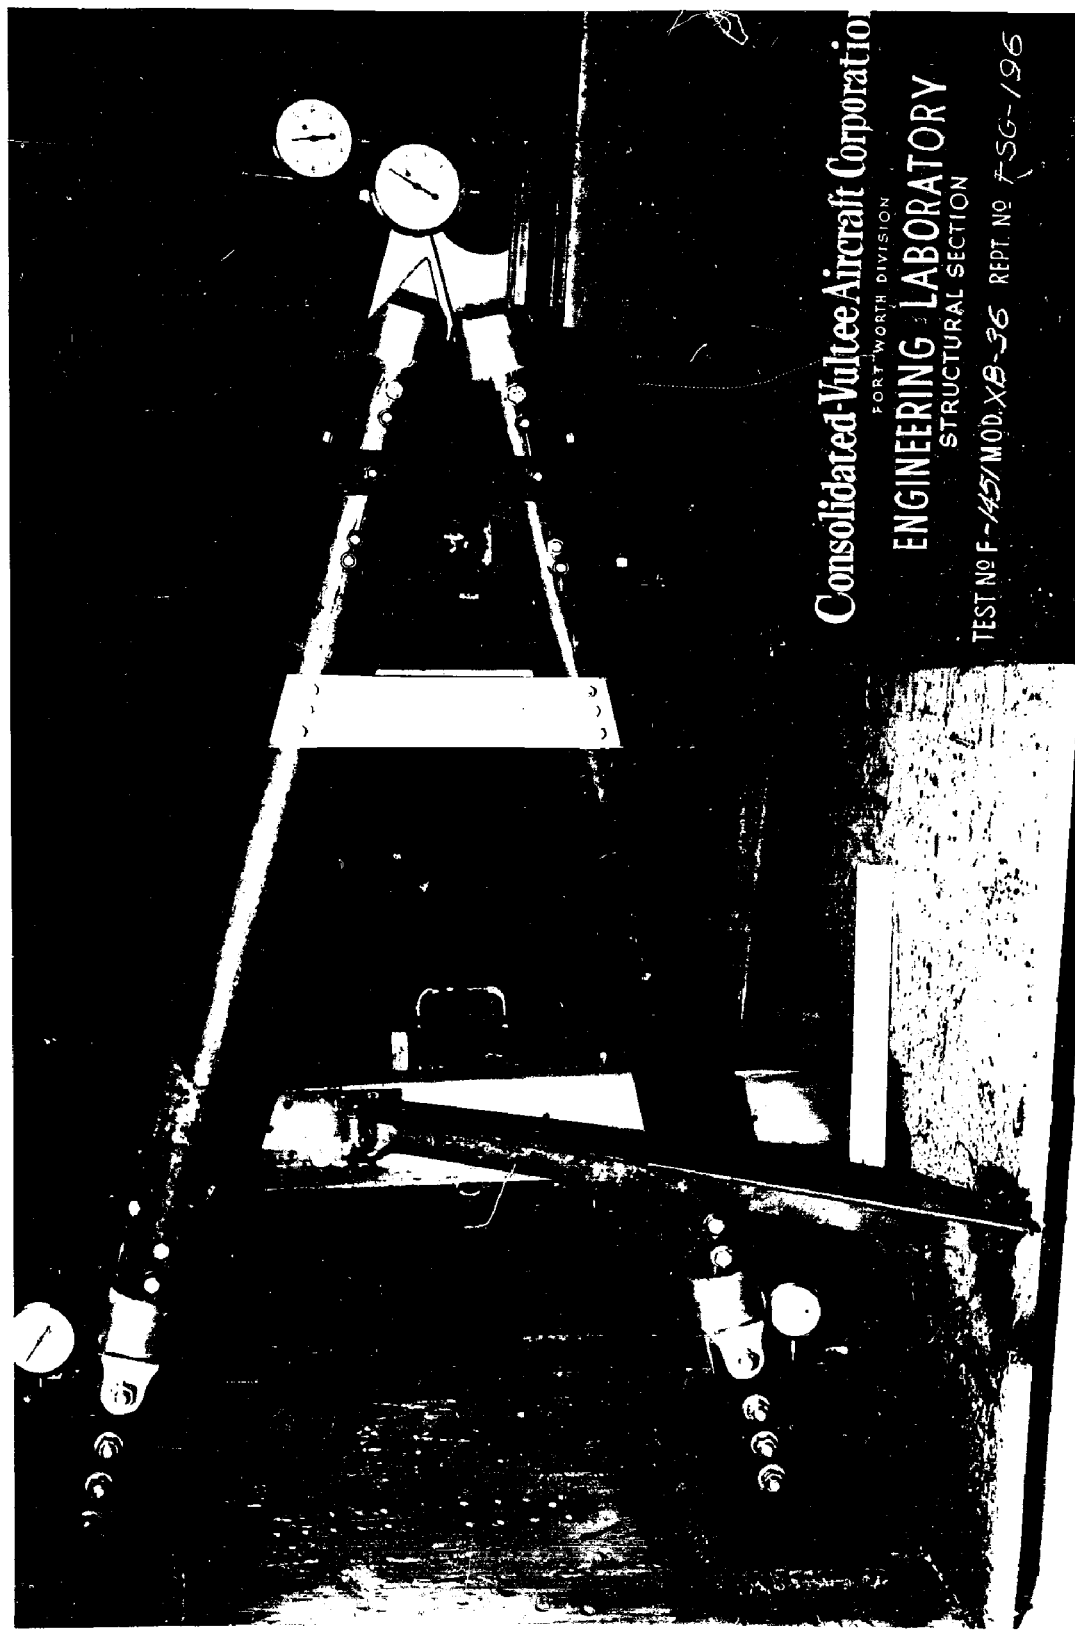
FIG. 7

TEST SET-UP  
LOCK LOAD
